**From:** Anthony Bell <anthony.bell@spower.com>  
**Sent:** Friday, January 25, 2019 1:54 PM  
**To:** Patrick White  
**Cc:** Wanda Parrish; Charlie Payne; Daniel Menahem; Ben Saunders  
**Subject:** FW: [EXTERNAL] Fwd: Tornado Destroys 170,000 Cadmium Telluride Solar Panels - Desert Sunlight 2015  
**Attachments:** Johnson 2013 TetraTech BAS Report.pdf; PV EHS One pager Final.pdf

Subject: Photovoltaic (PV) Solar Panel Experiment Results

Tetra Tech BAS (Tt BAS) has been retained by First Solar to conduct an experiment to determine if First Solar panels would produce hazardous leachate if disposed of in a municipal solid waste landfill. Of particular concern was the leaching potential of heavy metals, such as cadmium, from the PV panels after disposal. This experiment involved preparation of a test pad at a local landfill, crushing the panels with a typical municipal solid waste compactor, recovering all of the crushed pieces of the panels, performing grain size analyses of the pieces, performing TCLP and STLP laboratory testing of representative samples of the crushed panels, and preparation of this report.

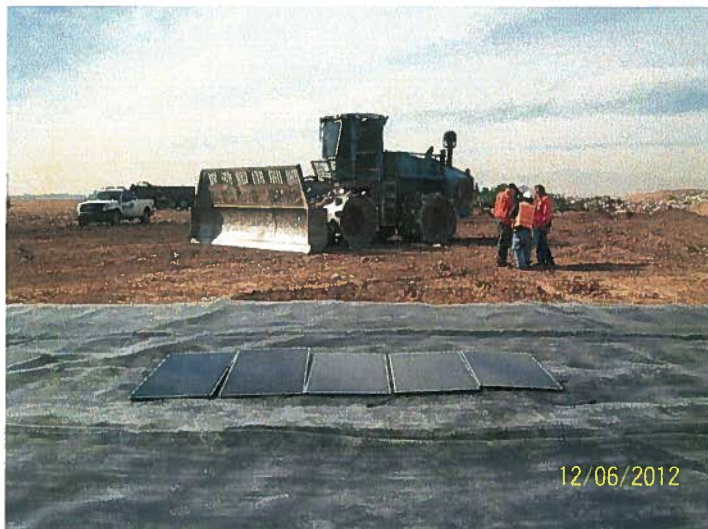
Five photovoltaic solar panels were crushed at the top of City of Glendale, Arizona, Municipal Solid Waste Landfill utilizing a compactor on December 6, 2012. The compactor used was a sheep's foot roller manufactured by Aljon, model 91K, with Caron cleats having a contact load of approximately 100,000 pounds (Picture #1). The PV panels were placed on top of a 22.5 x 40 foot tarp consisting of 60 mil. linear low density polyethylene (LLDPE) liner. The compactor made six passes over the test installation. The ground surface underlying the test installation consisted of loose soil which was firmer than the typical mixed waste conditions at the active face of a landfill. The residue from the crushed PV panels was collected and separately bagged for testing. This liner material is very flexible, however some puncturing of the liner did occur when the compactor rolled over the panels and a small amount of the crushed fines could not be recovered.

Picture #1 – Aljon model 91K compactor used to crush PV panels.

The procedure used to crush the PV panels may be considered a “worst case” for panel loading as the City of Glendale’s landfill compactor is one of the largest and

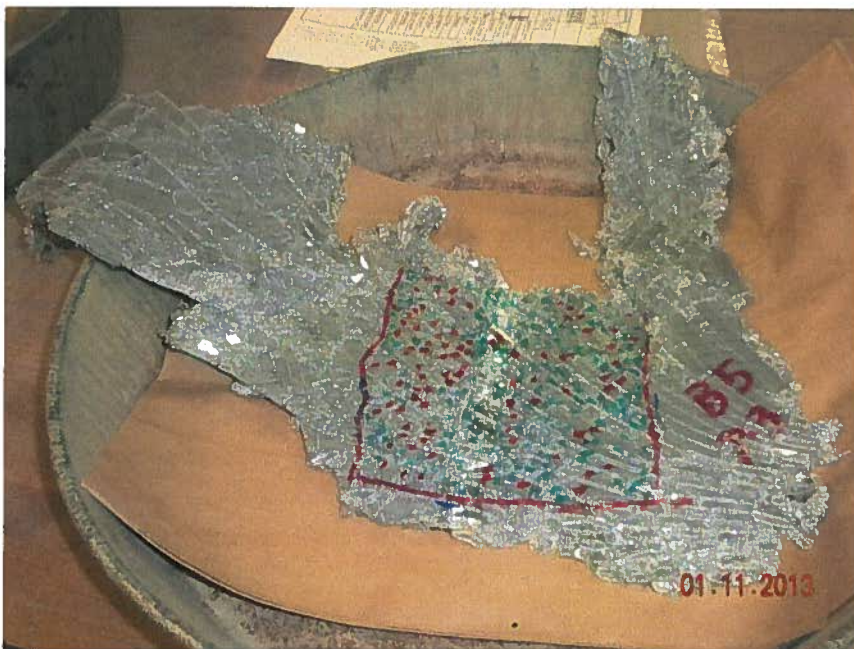
After crushing the PV panels appeared as shown in Picture #2 (Additional pictures in Appendix A). Delamination of the panels did not occur unless impacted by one of the compactor's feet. The compactor's feet created a punch-out in the panel the approximate size of the foot. The PV panel material punched-out of the panels was recovered to the extent possible and consisted of the finer fraction of the overall sample.

Picture #2 – Crushed PV Panel with Compactor Foot Punch-out

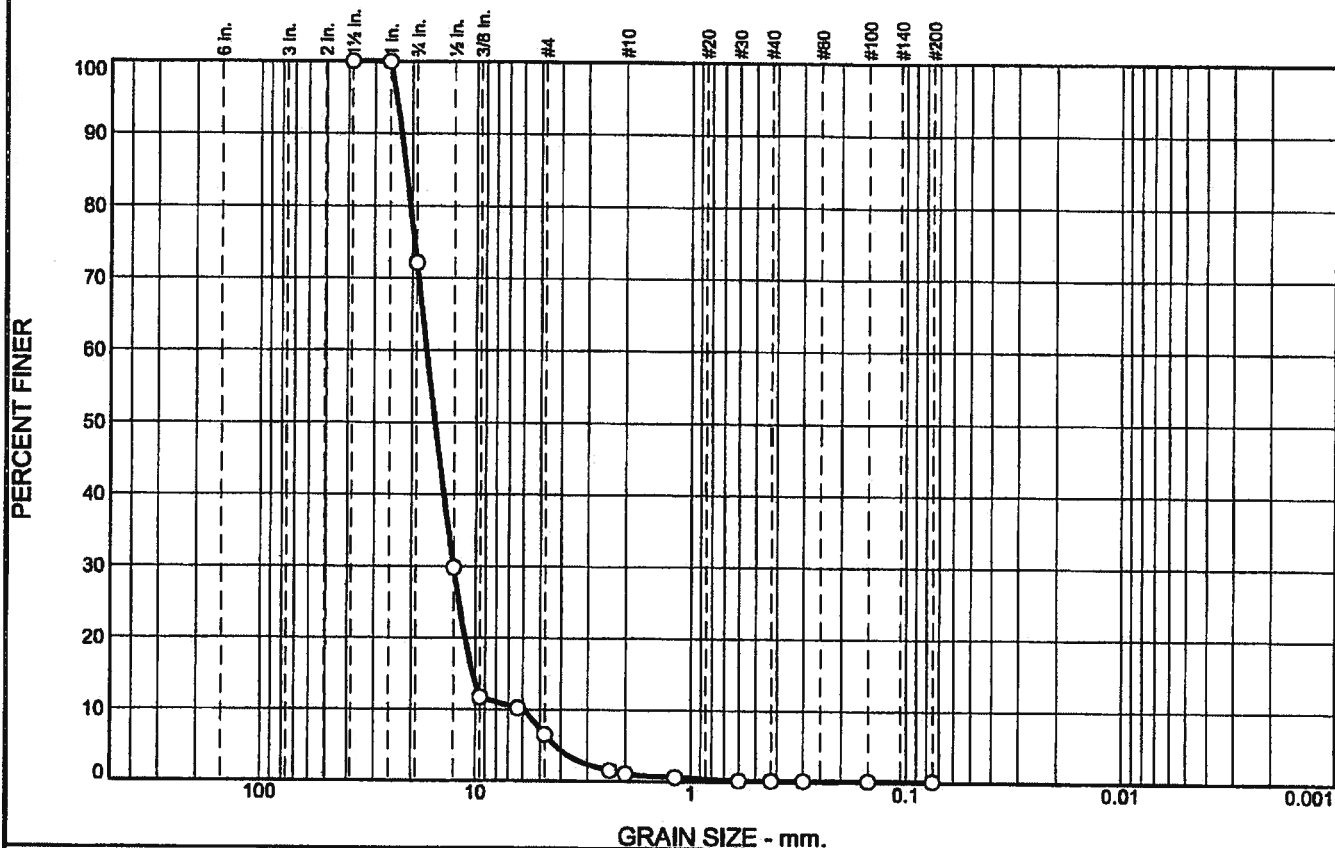
# Particle Size Distribution Report

% +3"	% Gravel		% Sand			% Fines	
	Coarse	Fine	Coarse	Medium	Fine	Silt	Clay
0	28	66	5	1	0	0

SIEVE SIZE	PERCENT FINER	SPEC.* PERCENT	PASS? (X=NO)
1-1/2"	100		
1"	100		
3/4"	72		
1/2"	30		
3/8"	12		
1/4"	10		
#4	6		
#8	2		
#10	1		
#16	1		
#30	0		
#40	0		
#50	0		
#100	0		
#200	0.2

The results of the tests including pebble counts and gradation tests are attached in graphical form (Appendix B). Note that for Panels 4 and 5 in Appendix B, the size distribution stabilized at a value above 0 because the sample included a small quantity of soil mixed with the panel pieces. On average, approximately one-quarter of panel pieces were smaller than 1 cm and less than 5% of panel pieces were smaller than 0.1 mm. Since waste characterization leaching tests use sample sizes smaller than 1 cm, leachate potential derived from these tests represents a fraction of the total volume of landfilled CdTe PV panel waste.

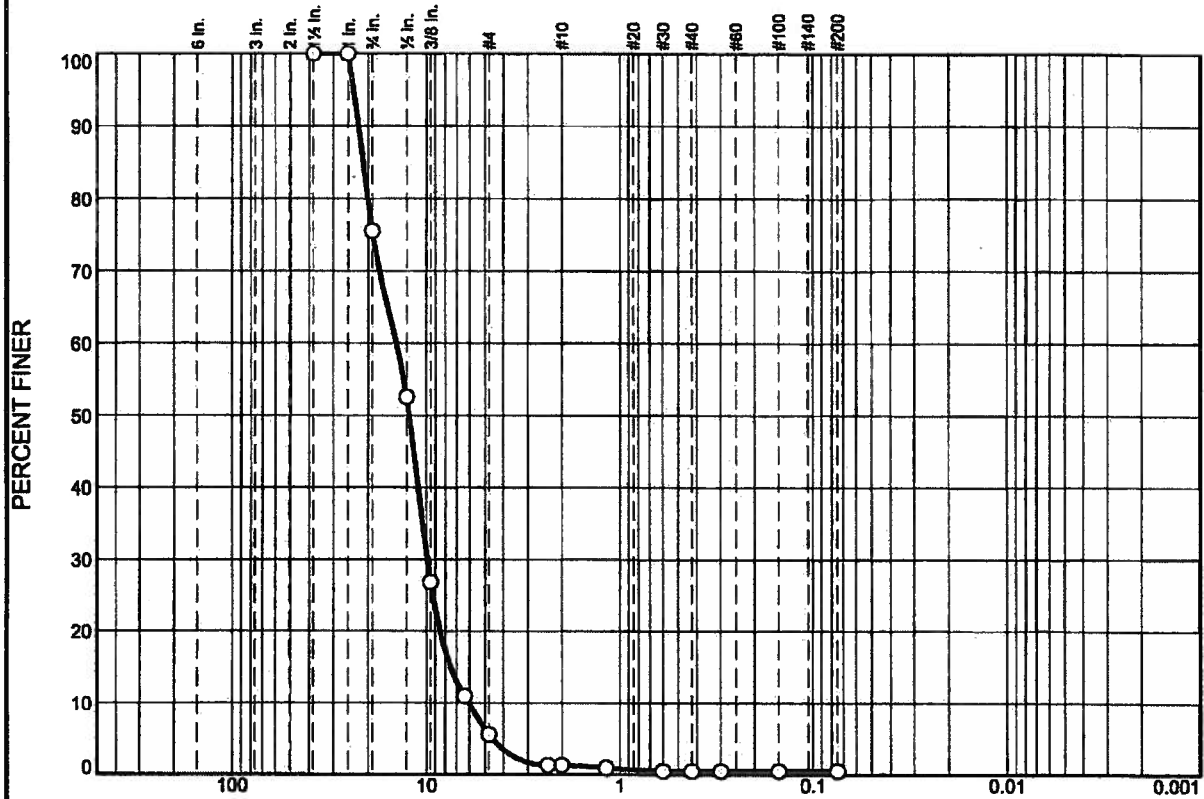
# Particle Size Distribution Report

% +3"	% Gravel		% Sand			% Fines	
	Coarse	Fine	Coarse	Medium	Fine	Silt	Clay
0	24	70	5	0	0	1

SIEVE SIZE	PERCENT FINER	SPEC.* PERCENT	PASS? (X=NO)
1-1/2"	100		
1"	100		
3/4"	76		
1/2"	53		
3/8"	27		
1/4"	11		
#4	6		
#8	1		
#10	1		
#16	1		
#30	1		
#40	1		
#50	1		
#100	1		
#200	0.5

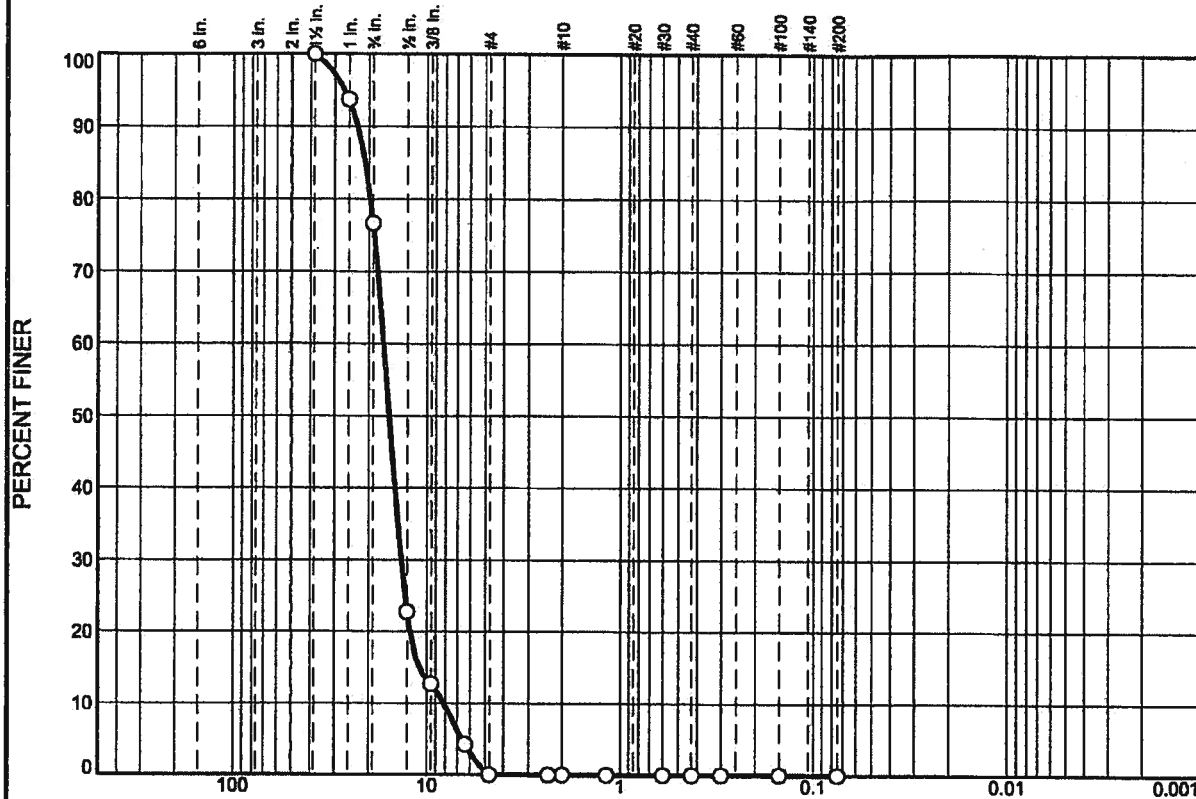
# Particle Size Distribution Report

% +3"	% Gravel		% Sand			% Fines	
	Coarse	Fine	Coarse	Medium	Fine	Silt	Clay
0	23	77	0	0	0	0

SIEVE SIZE	PERCENT FINER	SPEC.* PERCENT	PASS? (X=NO)
1-1/2"	100		
1"	94		
3/4"	77		
1/2"	23		
3/8"	13		
1/4"	4		
#4	0		
#8	0		
#10	0		
#16	0		
#30	0		
#40	0		
#50	0		
#100	0		
#200	0.0

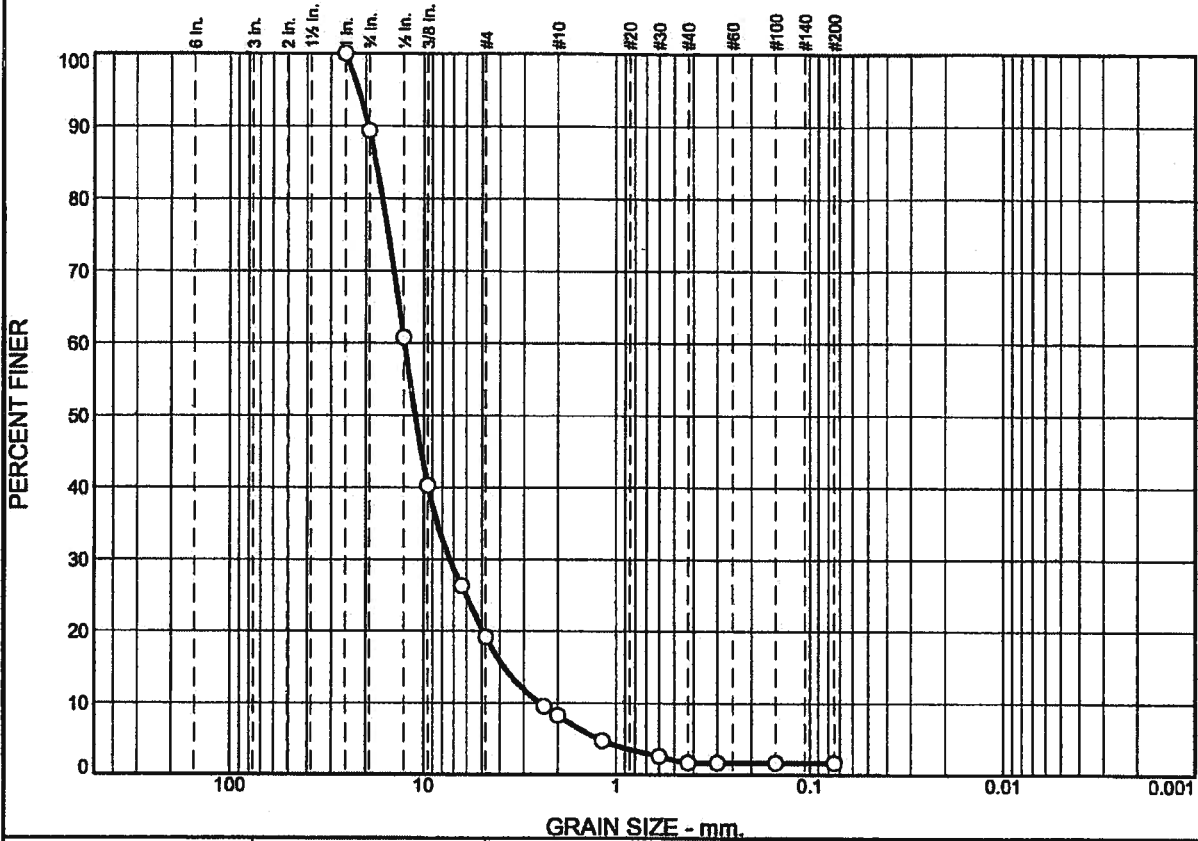
# Particle Size Distribution Report

% +3"	% Gravel		% Sand			% Fines	
	Coarse	Fine	Coarse	Medium	Fine	Silt	Clay
0	11	70	11	6	0	2

SIEVE SIZE	PERCENT FINER	SPEC.* PERCENT	PASS? (X=NO)
1"	100		
3/4"	89		
1/2"	61		
3/8"	40		
1/4"	26		
#4	19		
#8	10		
#10	8		
#16	5		
#30	3		
#40	2		
#50	2		
#100	2		
#200	1.7

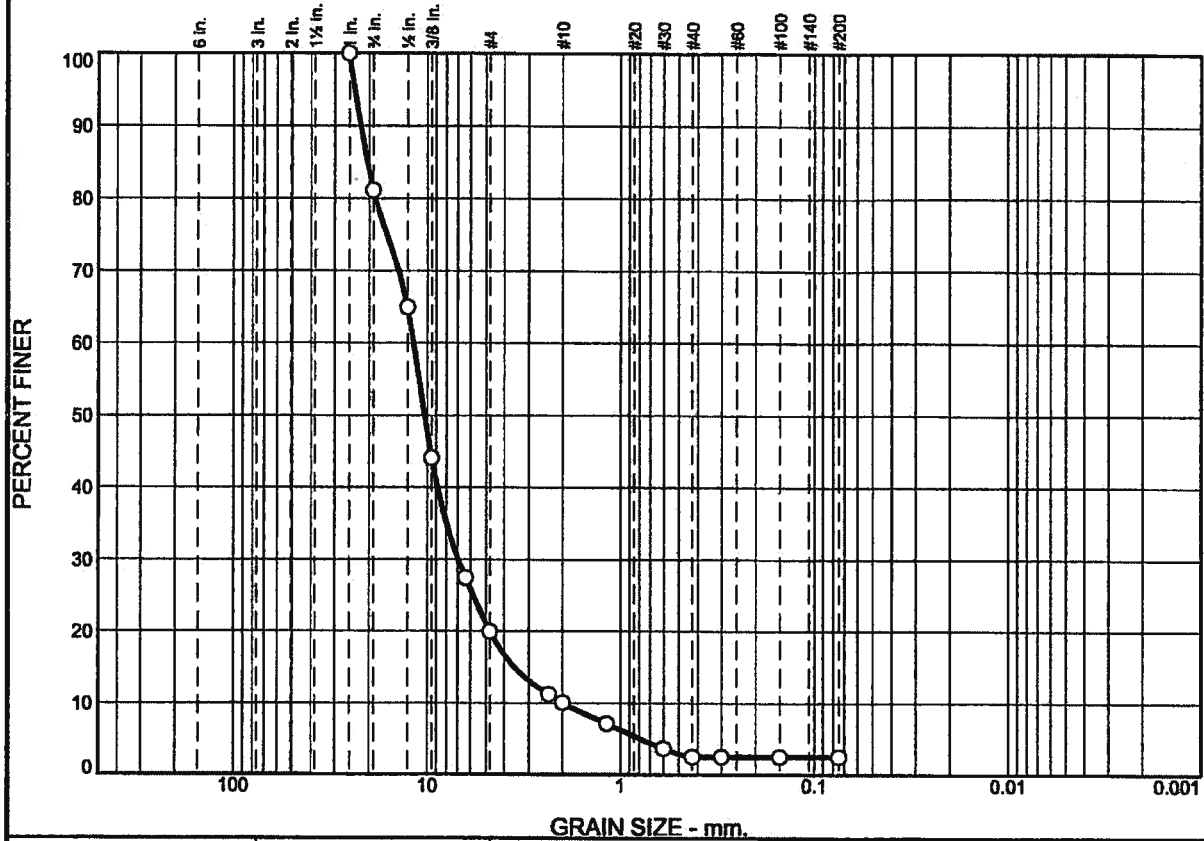
# Particle Size Distribution Report

% +3"	% Gravel		% Sand			% Fines	
	Coarse	Fine	Coarse	Medium	Fine	Silt	Clay
0	19	61	10	7	0	3

SIEVE SIZE	PERCENT FINER	SPEC.* PERCENT	PASS? (X=NO)
1"	100		
3/4"	81		
1/2"	65		
3/8"	44		
1/4"	27		
#4	20		
#8	11		
#10	10		
#16	7		
#30	4		
#40	3		
#50	3		
#100	3		
#200	2.5
